Heather View  
Town Green  
Slaggyford  
Brampton  
Cumbria  
CA8 7NS

### **Septic Tank Report**

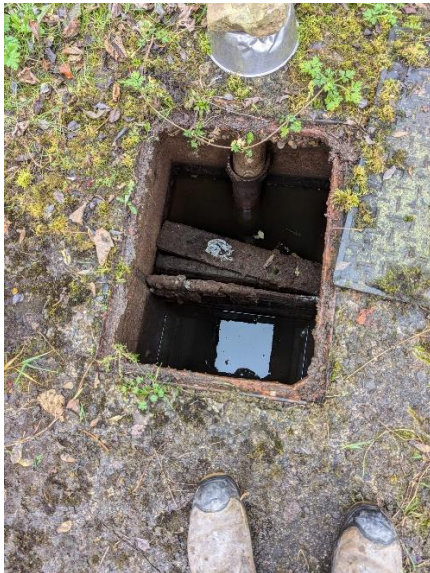
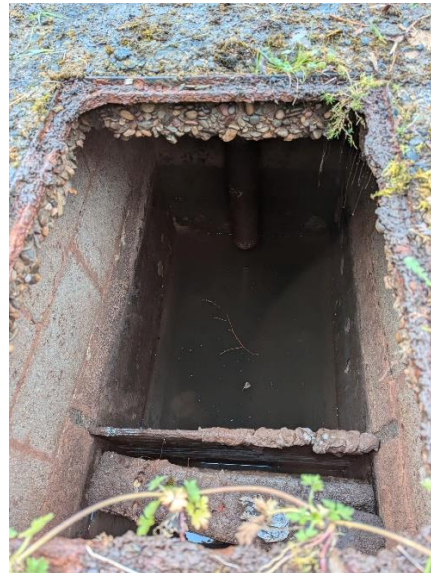
The existing septic tank is located at the end of the driveway to the right-hand side of the vehicular access gate, it is of a concrete block built, two stage design constructed prior to 1983 and therefore exempt from BSEN: 12566. A secondary baffle has been put in place in front of the solid baffle, one piece of wood from this has become dislodged and should be removed, other than this the tank appears to be structurally and operationally sound.

The outlet pipework from the tank was dye tested for the duration of our visit and no sign of dye was detected in any of the nearby water courses.

Given the above findings we believe the tank to be compliant with current regulations and that no further works are required at this time.
